**EMERGENCY SPILLWAY PERFORMANCE,
UPPER RED ROCK CREEK WATERSHED,
OKLAHOMA**

ARS-S-108

May 1976

By W. O. Ree¹

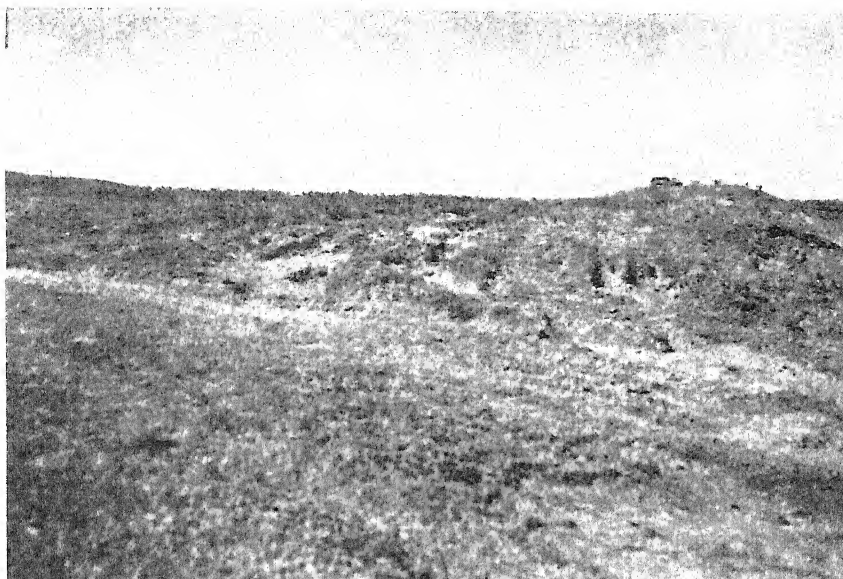
upon which the spillway discharges. The badly scoured portion to the right is on the bank of a natural channel or gully alongside the emergency spillway and was attacked by overflow from the spillway. Figure 4 shows the rills in the lower end of the spillway.

FIGURE 4.—Lower end of site 24 emergency spillway after flood of October 10-11, 1973.

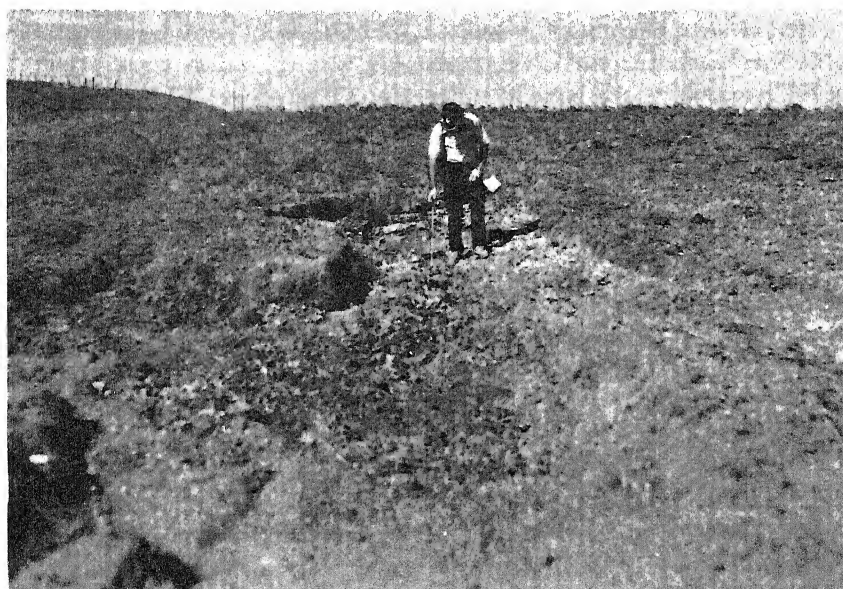
FIGURE 5.—Two-foot scour to the shale bedrock 90 feet downstream from site 24 spillway crest.

Figure 5 is a closeup view of the head of one of the deeper rills. The scour here is about 2 feet deep and extends to the shale bedrock. This part of the spillway was subjected to the 6.7 feet per second flow velocity. Immediately downstream of the spillway crest is a small area scoured to a depth of 5 inches (fig. 6).

The site 24 spillway started to erode during a flow event which had a peak mean velocity of 6.7 feet per second. The spillway appeared to have been heavily grazed, and this may have been responsible for its condition. Cattle trails and “stomp” areas were present in the spillway at the time of inspection. Therefore, it is reasonable to assume that the eroded areas also had suffered from similar cattle activity.

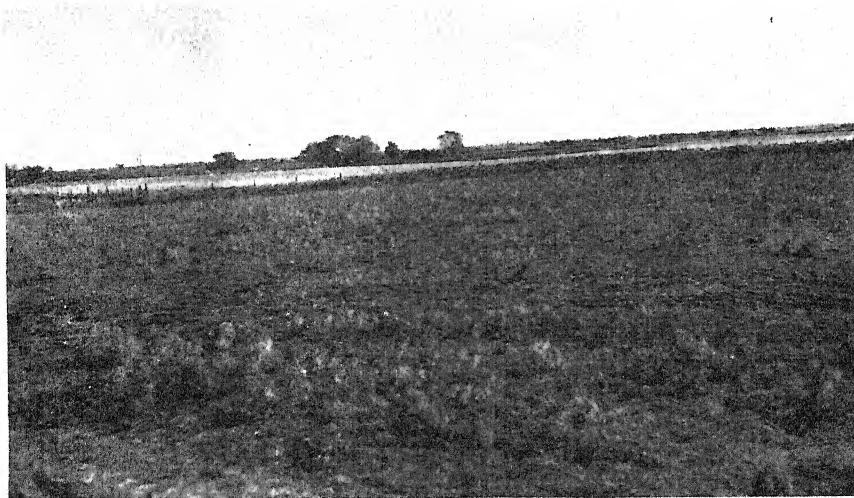
The spillway was in excellent condition after the flood. Some slight erosion was evident about 20 feet downstream from the crest and about 40 feet in from the right bank (fig. 8). It is not known whether this eroded area was present before the flood or whether there had been a weak spot in the cover here. An overall view of the spillway is shown in figure 9.

The excellent condition of the spillway should be expected because the flow velocity of 5.6 feet per second is below a suggested permissible velocity of 8 feet per second for a bermudagrass cover on clay soil and slopes of less than 5 percent, as determined from the "Handbook of Channel Design for Soil and Water Conservation" (cited in footnote 2). Uniformity of cross section and cover and moderate grazing can also be given some credit for the fine performance of the spillway.

FIGURE 9.—Overall view of site 25 emergency spillway after flow event of October 10–11, 1973. This spillway is in excellent condition. The cover is closely grazed bermudagrass, with a scattering of broomweed and some small, fine-leaved grass.
